Rim rash ... what's the treatment?

Words & photos: Rob Tanner, Southern Tasmania Chapter

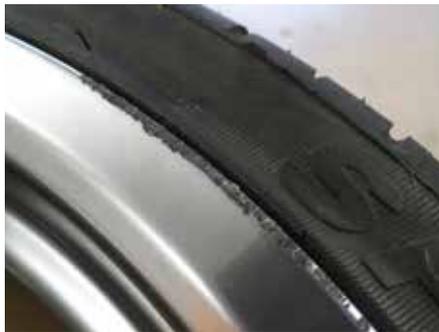
Rim rash is that dreaded disease caused by the occasional rogue gutter which jumps out and savagely attacks our precious rims!

The dreaded rim rash ...

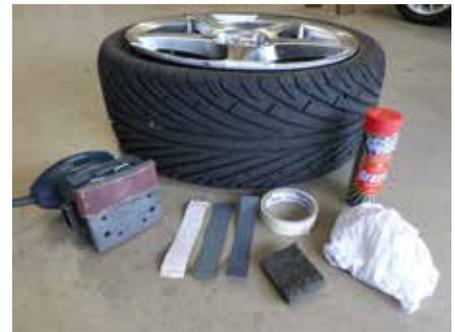
What you need for the job ...

Materials required: A small electric palm sander, some narrow strips of emery cloth, and wet and dry paper, from coarse down to about 800 grit, a grey automotive scourer (available from any auto paint shop), some Brasso, rag, and masking tape.

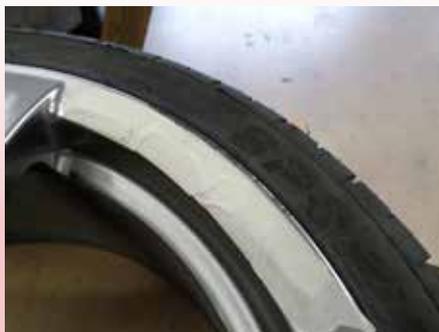
Mask around the damaged area ...

1. Remove the wheel, remove the valve, and pop down to your nearest tyre outlet, and have them break the bead on the front only.
2. Mask off around the damaged area/s with a couple of layers of masking tape.

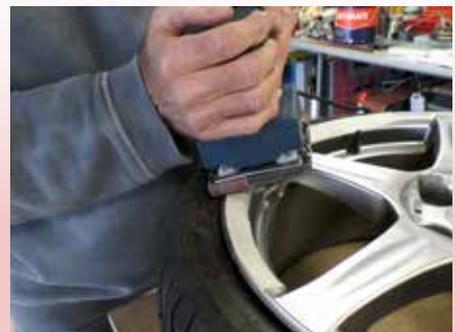
Carefully sand out the damaged areas ...

3. Cut your emery cloth and wet and dry into strips about 25-30mm wide, and fit the coarsest one to one edge of the sander.
4. Carefully sand out the damaged areas, until the worst of the damage is gone (some of this can be done by hand if you wish).

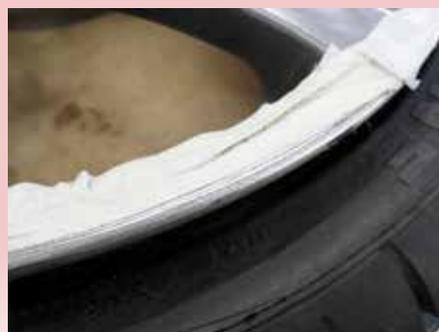
Sand each stage using progressively finer paper ...

5. Then sand by using progressively finer paper at each stage until you get to the 800 grit (three or four stages are plenty).
6. When you have the repaired area nice and smooth, finish off with the grey scourer, and then some Brasso, to get a nice polished finish.

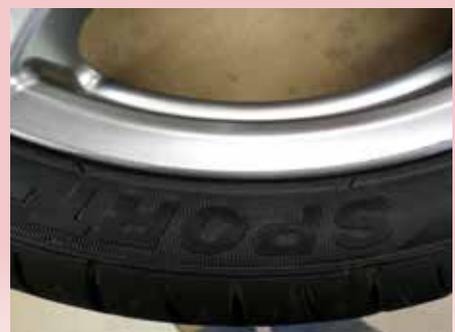
Finish off to a polished surface ...

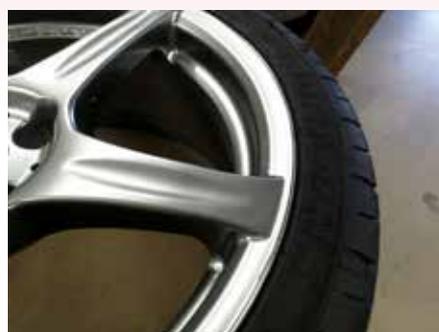
Beautiful!

Note that the wheel used for this article is from an NB SE Turbo, which has a "chrome" silver paint finish. You will see some faint feathering at the painted edges where you did the repair, but it looks 100% better than the rash.

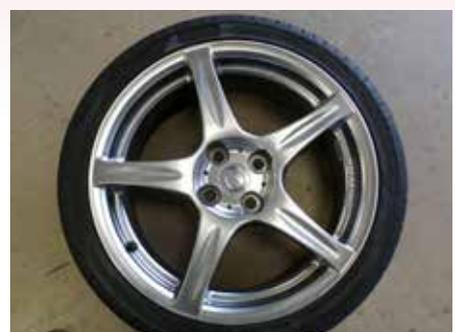
Like a bought one!

7. Once complete, return to your tyre outlet and have them reattach the tyre to the rim. Pump up the tyre, and finish off with a coat of tyre gel, re-fit the wheel, and your beautiful MX-5 is looking pristine again!
